Safety measures for earth dams on basis of instrumentation data, dam site location and reservoir volume

ABSTRACT: It is important to ensure long-term safety of dams constructed near populated cities and industrial areas. In this regard, in addition to the adoption of appropriate considerations during design and construction of a dam, the necessary controls should be made during operation periods to ensure its proper functionality and safety.

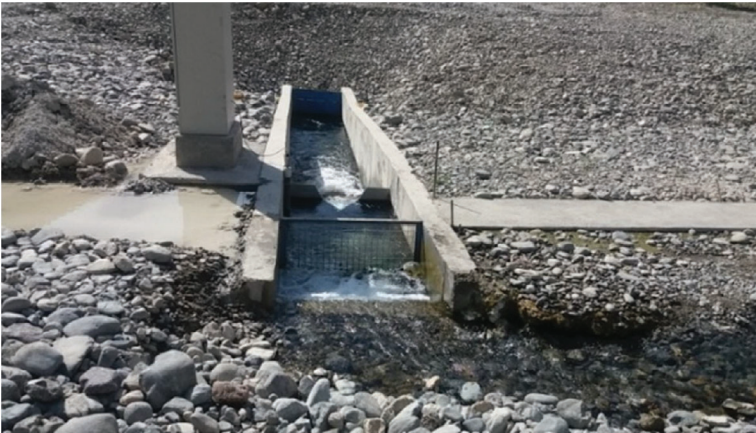
Figure 3. A view of the V-notch seepage control in Silveh dam

The seepage through the dam body and its foundation has been continuously measured using a V-notch measuring weir (Figure 3). The maximum outflow recorded by the V-notch was

reported as 83.5 lit/sec in Nov. 2018 at 1572.2 m.a.s.l. However, an unpredicted but controlled seepage was also reported at the right abutment of the dam with the maximum value of 9 lit/sec. This discharge value, for 6 months ago to now have remained constant (Abgeer, 2018).

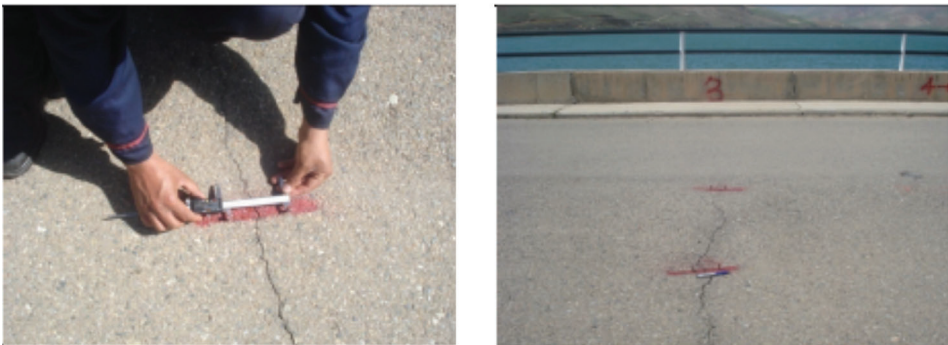
Figure 5. Numbering and monitoring of cracks in the crest of Mahabad dam

1. The longitudinal and transverse cracks were reported atop the crest, in adjacent of the maximum height cross section. Monitoring of the cracks showed that the length and the aperture of them did not change significantly after a few months. In Figure 5 some observed cracks on the dam crest are shown.

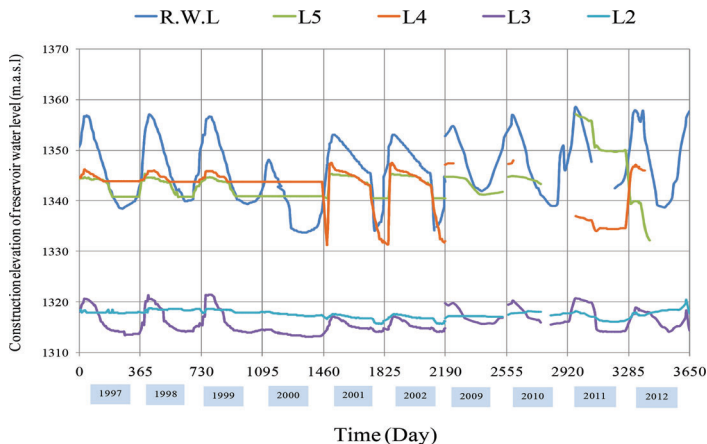
Figure 6. Pore water pressure in left abutment side of Mahabad dam vs. time

3. Based on the inspector's observations and recorded pore water pressures by the Casa-grande piezometers on the left side of the dam, in long period time, it seems that the cutoff-wall in this area was not working properly and need repairs. The main reason of it's about the high pore water pressure in piezometers in dam foundation in left abutment of dam. In Figure 6 pore water pressure in left abutment side of Mahabad dam in 15 years period time is shown. From this figure, in L4 & L5 piezometers, pore water pressure level almost was in reservoir water level, that it shows cutoff-wall didn't have good performance in this area. This assumption was also partially confirmed by the results of geophysical investigations.

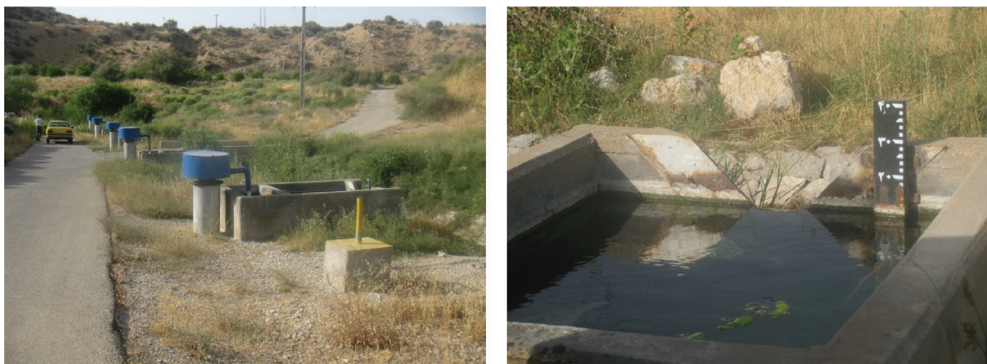
Figure 8. Measuring weir and seepage collection system at downstream of Doroodzan dam

During a time period of 4 years from 2011 to 2015, the maximum lateral movements of the dam crest have been reported as 16 mm, in accordance with the geodetic data. An unpredicted but controlled seepage was also reported at the left abutment of the dam with the maximum value of 120 lit/sec (Abgeer, 2014a).

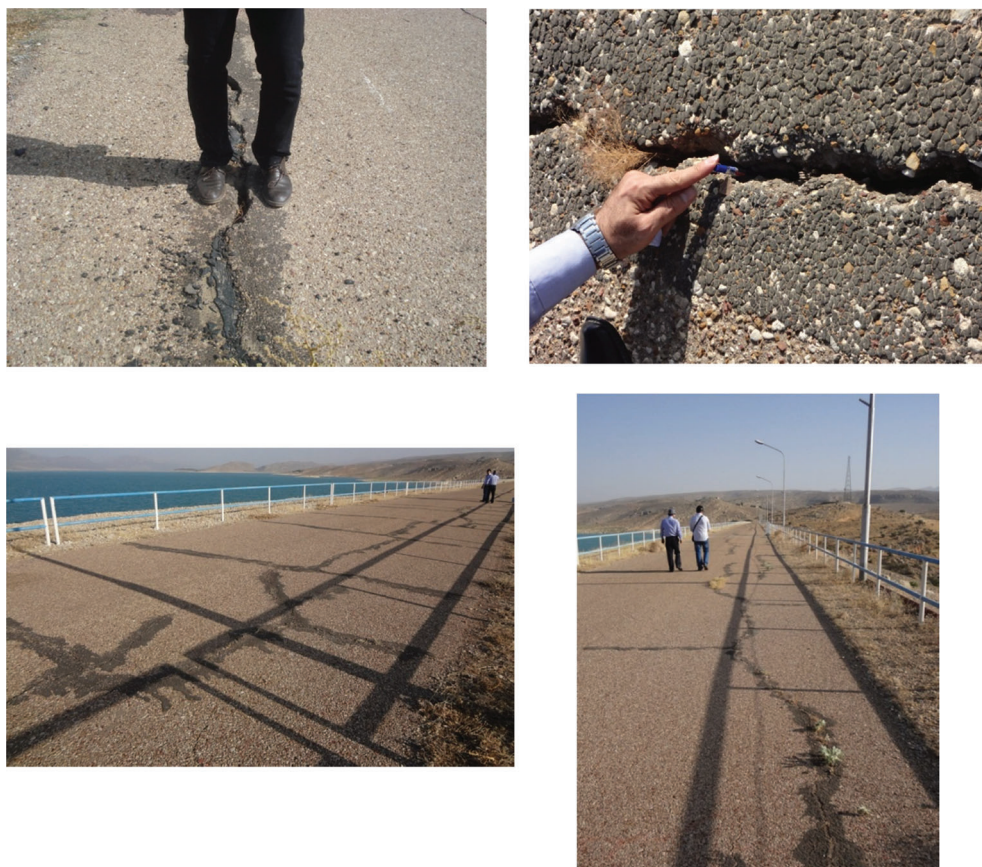
Figure 9. Cracks in crest of Doroodzan dam

1. The longitudinal and transverse cracks were reported atop the crest. All data shows that the cracks length changes with changing of water level in reservoir, especially the top of the reservoir water level. These cracks are generally seen across the crest, most of which lie down between the dam axis and dam downstream. The longitudinal cracks were reported atop the crest with the maximum length of 25 m, depth of 3 m and aperture of 70 mm. Some of the cracks in the crest of Doroodzan dam are shown in Figure 9.

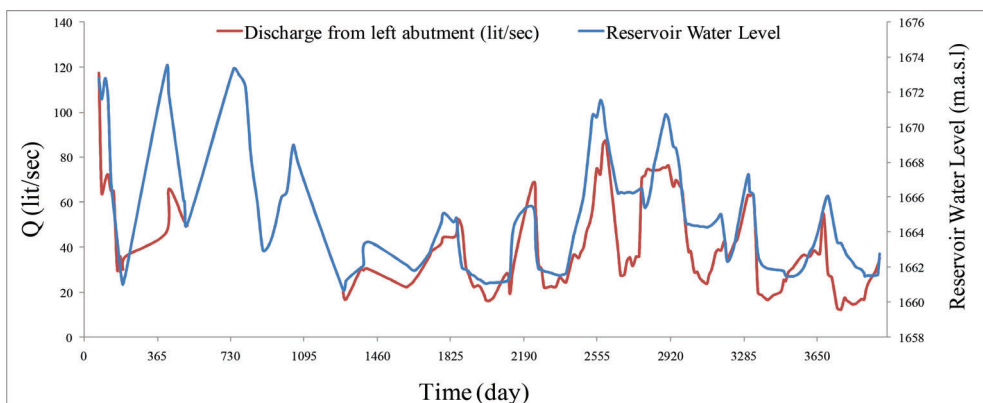
Figure 10. Variation of left abutment discharge and reservoir water level v.s time

2. The unpredicted seepage was reported at left abutment of dam with the maximum value of 120 lit/sec. The measurements indicate that seepage charge dependence on the reservoir water level. These changes are shown in Figure 10.

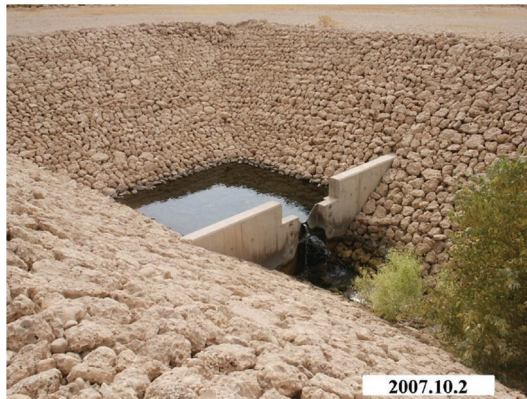
Figure 12. Measuring weir of Masjed-Soleyman dam

The seepage through the dam body and its foundation has been continuously measured using a V-notch instrument (Figure 12). The maximum outflow recorded by the V-notch 7 years after first impounding was reported as maximum 20 lit/sec (Jafarzadeh & Javaheri, 2003, Moshanir, 2007).

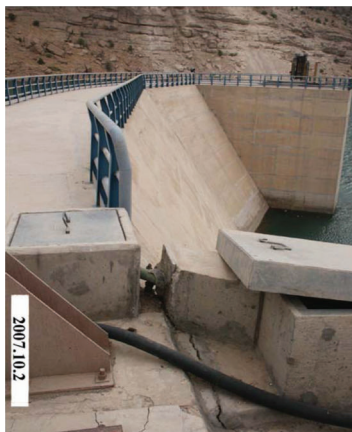
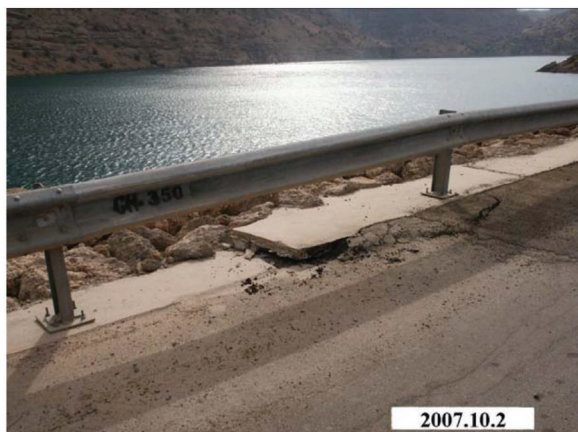
Figure 13. Cracks in the dam crest of Masjed-Soleyman dam

1. The longitudinal and transverse cracks were reported atop the crest. In Figure 13, a number of the cracks in dam crest is presented.
2. Due to the soft clay consolidation in the core of dam, vertical undesirable deformations on the Masjed-Soleyman dam crest is observed (Figure 14).
3. Some of Casagrande piezometers and electrical pore water pressure piezometers failure was reported at parts of the dam and there are no data available.

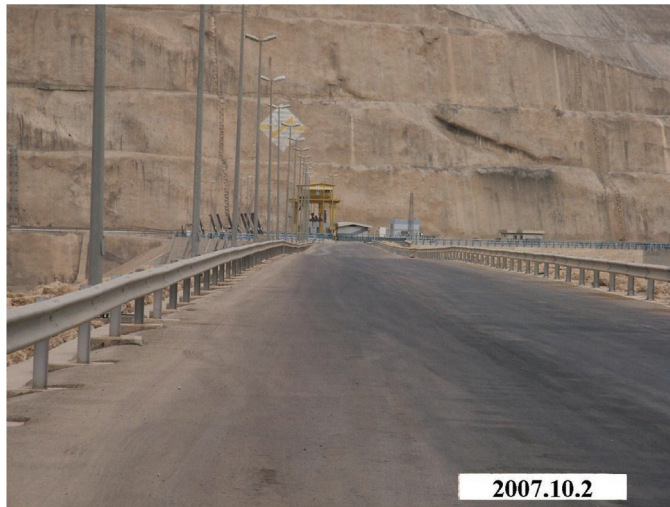
Figure 14. Bumpy crest of Masjed-Soleyman Dam due to non-homogeneous vertical deformations

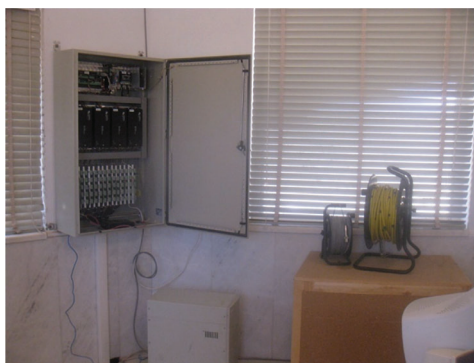
For this dam also a variety of instruments were installed. Unfortunately, due to malfunctioning of reading and data acquisition system after a short period the reading of the instruments were not possible. Figure 16 shows this system at control room.

As mentioned, the main problem in the instrumentation system of the Izadkhast dam is the inappropriate performance of the data logging system which causes no data to be recorded by the instruments from 7 years ago (Abgeer, 2014b). Also, operator of this dam did not took care about the installed instrumentation facilities (Figure 17).

Figure 16. Useless data acquisition system of instruments in control room of Izadkhash dam

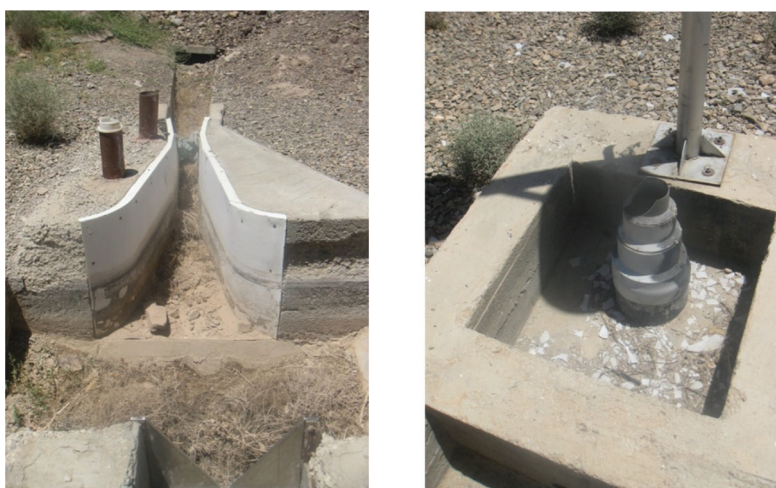
Figure 17. Inappropriate maintenance of installed instruments in Izadkhash dam, Weir (left) and Piezometer (right)
